**DOCUMENT NO. 63407-701**

TITLE:	Eastern Sheet Metal Fiberglass Duct Erosion Test Report
MATERIAL TYPE:	ESMI Duct Liner
CUSTOMER:	Eastern Sheet Metal 8959 Blue Ash Road Cincinnati, Ohio 45242
AWV PROD. NO:	63407
ESMI P. O. #:	20420

## DUCT EROSION TEST

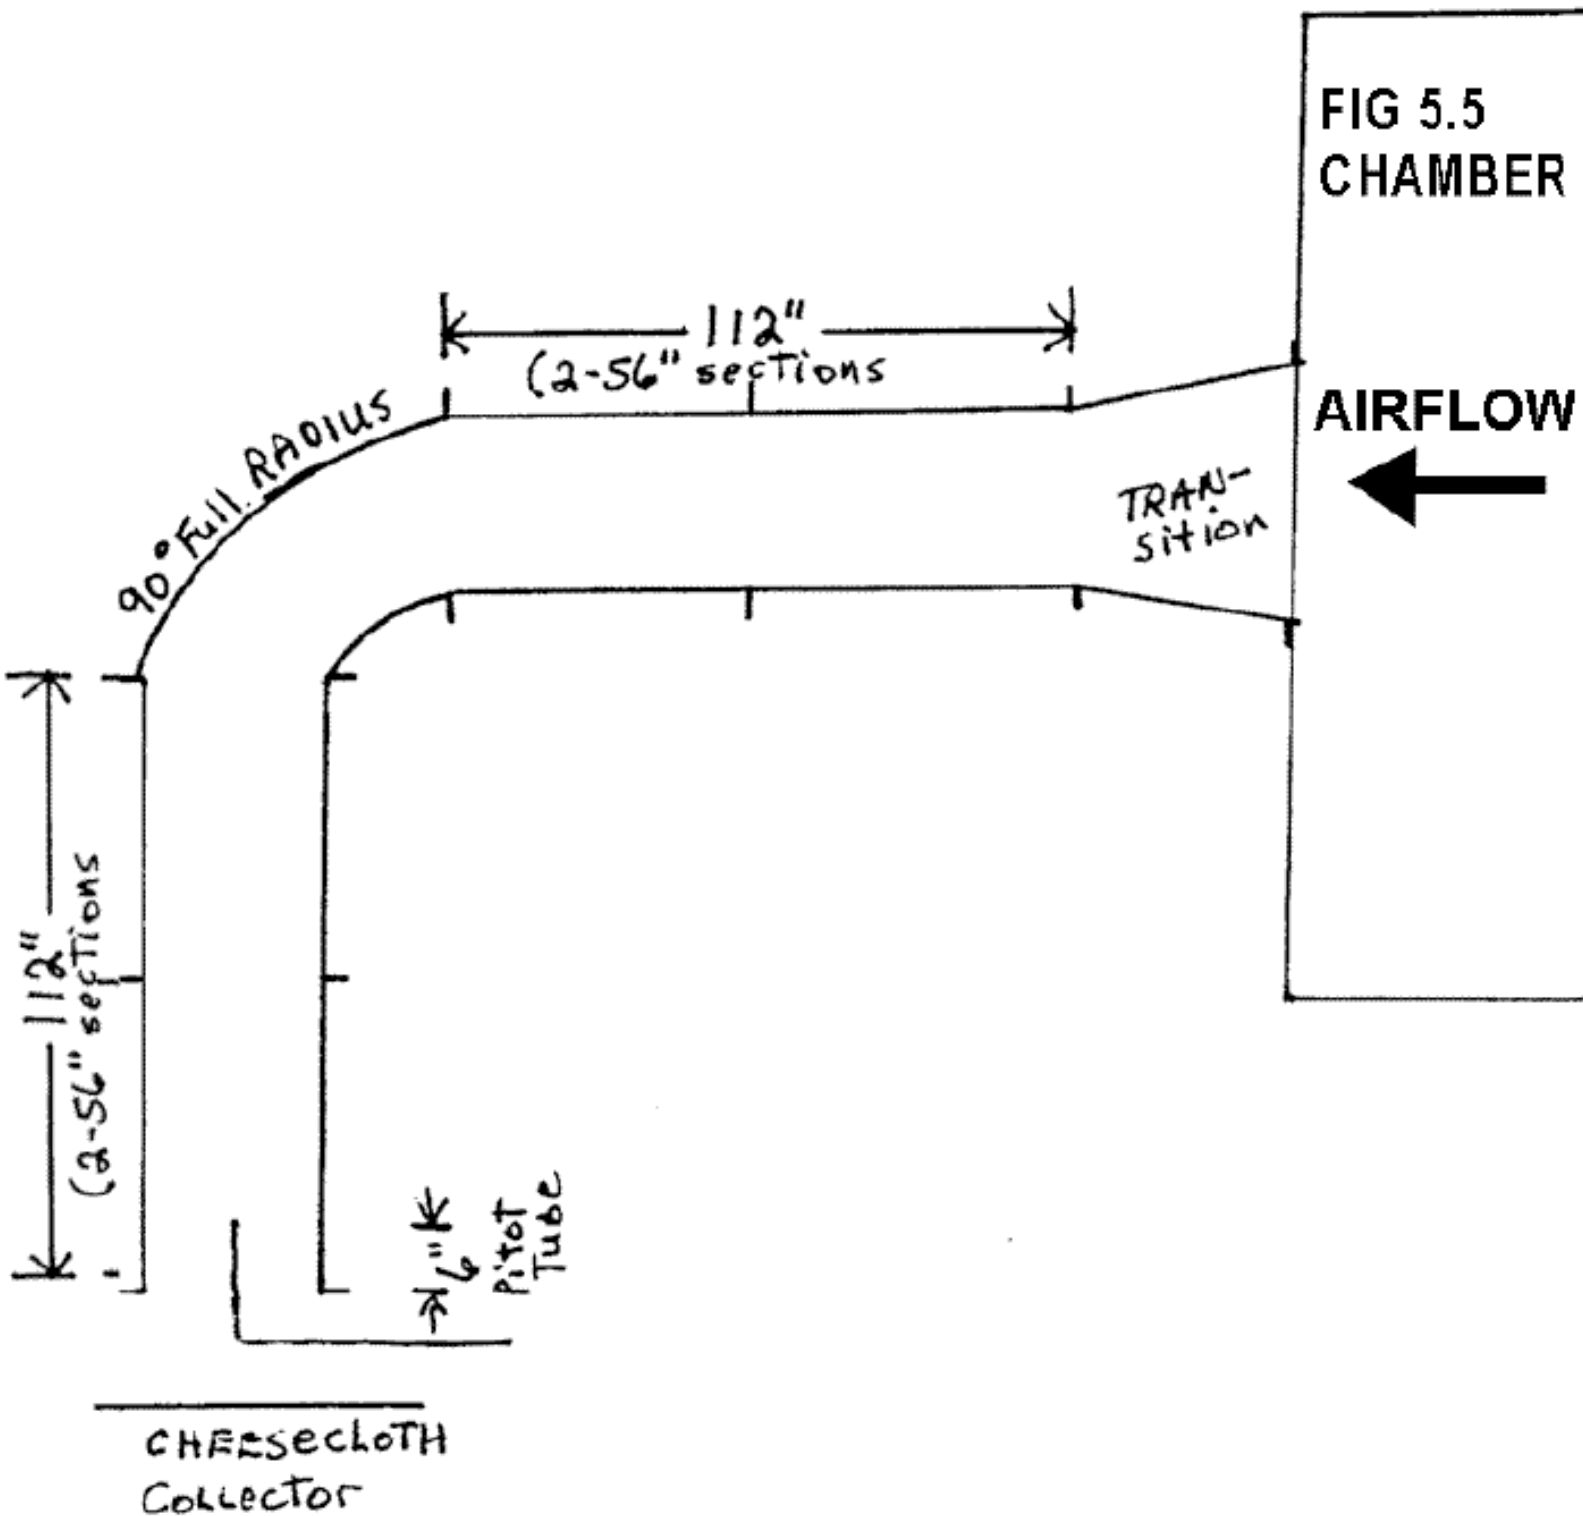
The duct liner sections were assembled and connected to the AMCA (fig. 5.5) test setup and (fig. 6.5) flow measurement apparatus, on the downstream end of the tapered transition. Air flow was increased from zero (0) until a center line velocity of not less than 10,000 feet/minute was obtained. Velocity was measured by means of a Pitot Tube (at the end of the duct) connected to a portable manometer. We ran a duct free blow for one (1) hour checking velocity periodically. At the end of the hour, we positioned a cheesecloth collector approximately 1 foot downstream of the end of the duct. We then ran a 4 hour test checking for anomalies at one (1) hour intervals. (At each hour interval, velocity was checked to be sure a 10,000 feet/minute minimum was maintained.) Every hour during the test the collector was inspected for erosion, using tape. No noticeable anomaly on the tape determined a successful completion of the test. Following on the next page is a list of materials and duct construction used in the test.

<b>Description</b>	<b>Page No.</b>
<b>Title Page .....</b>	<b>1</b>
<b>Table of Contents, Test Purpose, Comments .....</b>	<b>2</b>
<b>Lab Description .....</b>	<b>3</b>
<b>Explanation &amp; Results of Duct Erosion Test .....</b>	<b>4</b>
<b>Material &amp; Duct Description .....</b>	<b>5</b>
<b>Sketch of Setup .....</b>	<b>6</b>
